**Kineticcorp**<sup>TM</sup>  
Forensic Engineering and Visualization

Case Name: *Bacho v. Rough Country, LLC*

As requested, Kineticcorp investigated and reconstructed a multiple vehicle crash that occurred at approximately 8:06 PM on December 22, 2012. The crash occurred at the intersection of Lower Fayetteville Road and Newnan Crossing Bypass in Newnan, Georgia. A southbound 1999 Chevrolet K1500 pickup truck, driven by Taylor Long, failed to stop at a red light and impacted an eastbound 2012 Toyota Sienna driven by Natalie Bacho. According to the police report and phone records, Mr. Long was on the phone with his girlfriend before and during the accident.

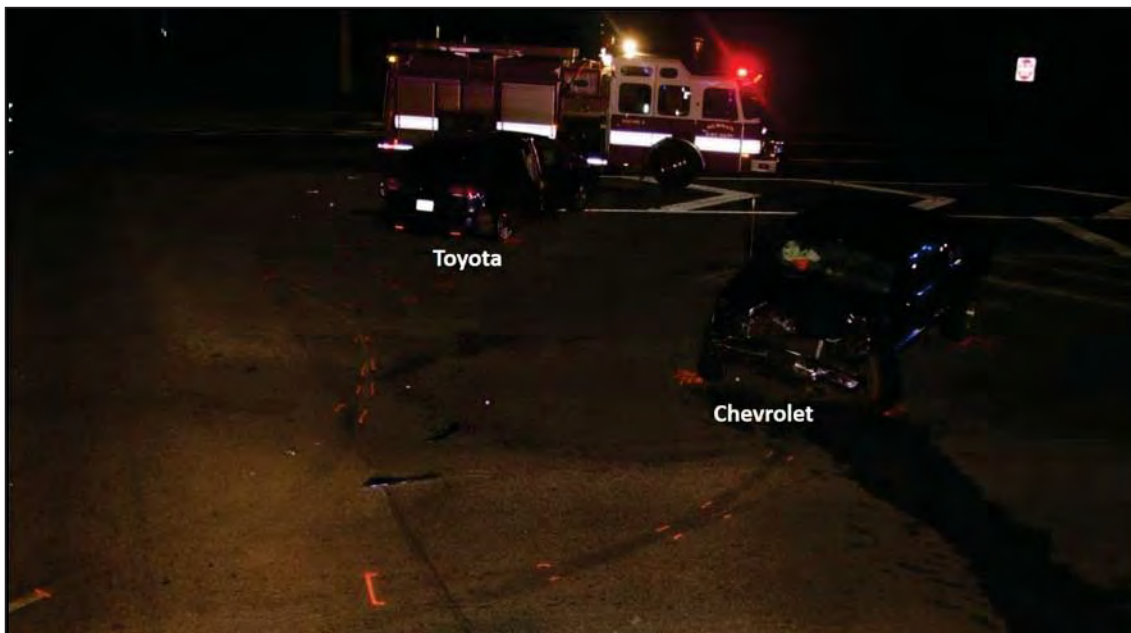
*Figure 1*

Figure 1 is a photograph looking east taken by police that depicts the rest position of the Toyota Sienna and Chevrolet K1500. Eastbound and westbound traffic lanes are separated by a double yellow line, northbound and southbound traffic lanes are separated by a narrow median. The accident occurred at the intersection of southbound Newnan Crossing Bypass and Lower Fayetteville Road. No adverse weather conditions were reported at the time of the accident and the road surface was dry. The posted speed for both roadways at this intersection was 45 mph.

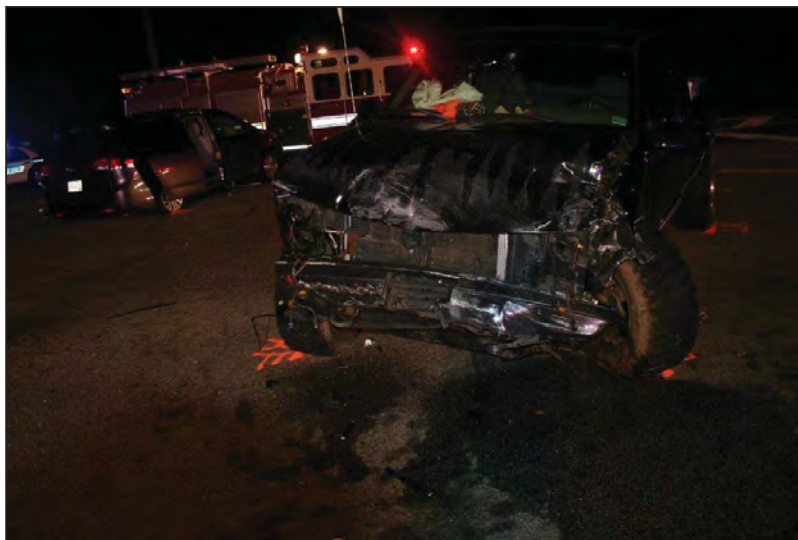
*Figure 3 – Accident Area*

Figure 3 contains a photograph taken by police on the night of the crash. This photograph shows the two vehicles at their respective points of rest. Orange spray paint on the roadway is also visible in the photographs. This paint was used by police to mark the locations of physical evidence and vehicle rest positions. Also visible in Figure 3 is the deformation to the left front wheel of the Chevrolet.

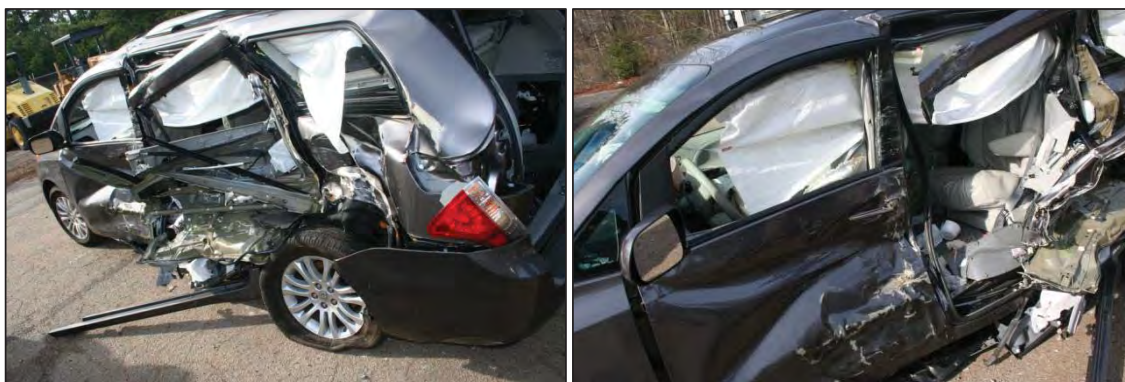
*Figure 8 - 2012 Toyota Sienna Exterior*

Ms. Bacho's vehicle was a 2012 model year Toyota Sienna (VIN – 5TDYK3DC9CS227448). This four-door, two-wheel drive van was equipped with a 3.5-liter, 6-cylinder engine with the XLE trim package. The Sienna was not available to Kineticcorp for inspection. Kineticcorp determined that the subject Sienna, with the driver and five passengers, weighed approximately 5,275 lbs. at the time of the crash. Figure 8 contains photographs of the Toyota taken by police during an inspection. As can be seen in the figure, the Sienna sustained severe impact damage to the driver's side of the vehicle extending from the driver door and rearward across the B and C pillars. The left rear wheel of the Toyota was engaged during the collision; the wheel rim was fractured, the tire was debanded and the wheel assembly was deformed inward on the top edge (caster change) and the rear edge of the wheel was rotated inboard (toe change).

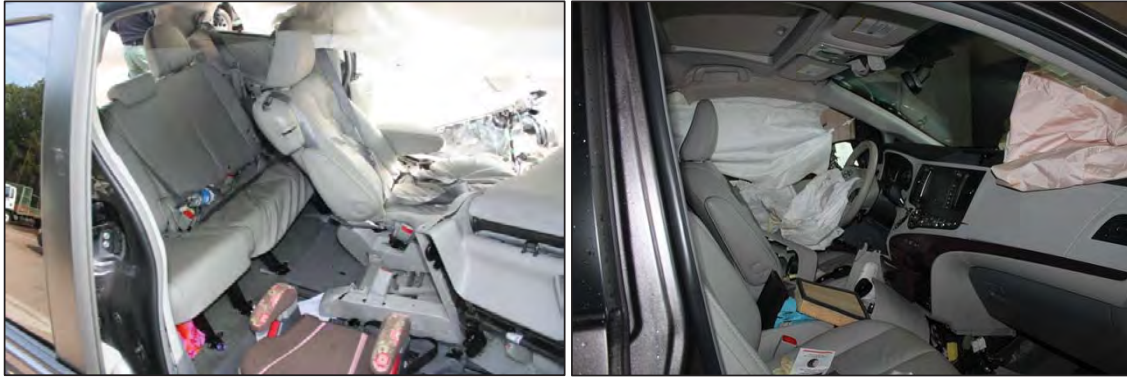
*Figure 9 – 2012 Toyota Sienna Interior*

As a result of the crash, the driver's side of the vehicle and occupant compartment of the Toyota Sienna sustained deformation and intrusion. Figure 9 contains photographs of the interior of the Sienna. These photographs show the occupant compartment from the passenger side of the Sienna. As seen in the photos the side and frontal airbags deployed. Inboard deformation can be seen extending from the driver's door across the rear sliding door and into the area just rearward of the C-pillar.

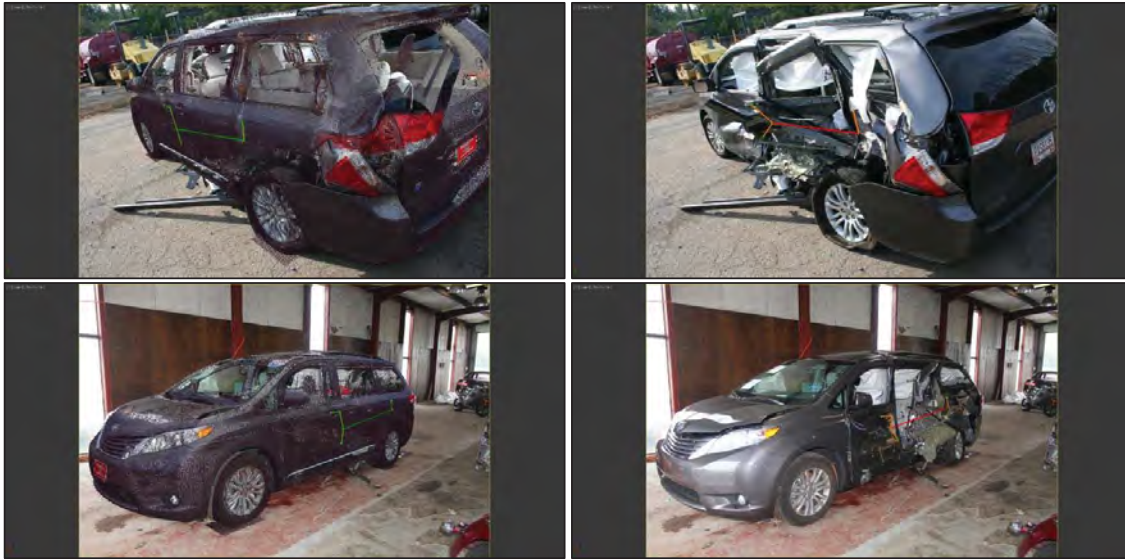
*Figure 12 – 2012 Toyota Sienna Damage Photogrammetry*

Kineticcorp conducted photogrammetric analysis on provided inspection photographs of the subject Toyota. The photographs were compared to the exemplar scan data to evaluate the deformation of the Toyota. Figure 12 contains four representative images from the analysis. The images on the left show the exemplar scan model aligned to the photograph. Green points and connecting lines indicate the undamaged locations selected for comparison. The images on the right contain the deformed subject vehicle. The orange lines connect the deformed locations corresponding to the selected green points. The red line connects across the deformed sliding door area. The deformation indicated by this line is only an approximation due to the door removal during extrication and the subject vehicle being unavailable for inspection.

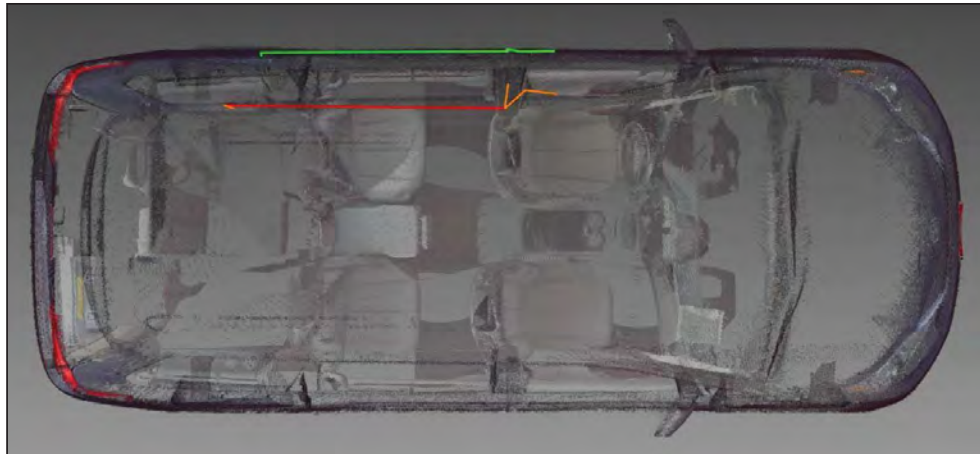
*Figure 13 – Toyota Damage*

Figure 13 below is a top view of the subject and exemplar vehicles superimposed. Again, green lines represent the undamaged geometry and the red and orange lines indicate the approximate extent of damage caused by the impact of the Chevrolet. The inboard deformation is about 12 inches and the damage width is about 96 inches. These dimensions were used to verify results from the HVE simulation.

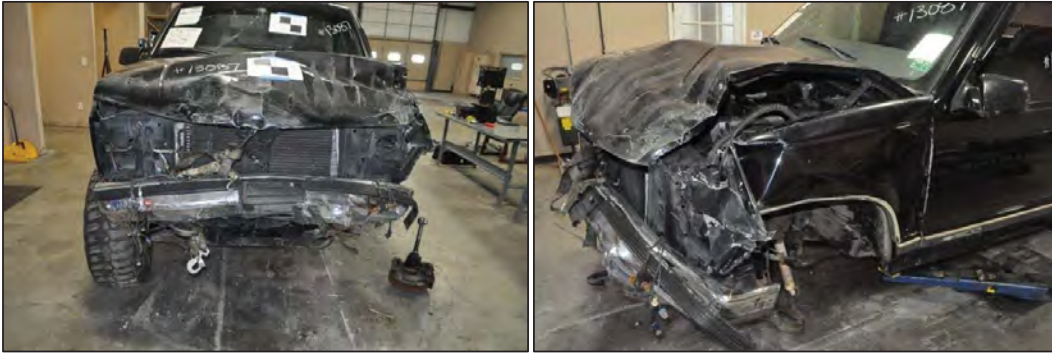
*Figure 12 - Subject 1999 Chevrolet Pickup*

The pickup involved in this crash was a 1999 model year Chevrolet K1500 (VIN – 1GCEK19R6XR124996). This two-door, extended cab truck was equipped with a 5.7-liter 8-cylinder engine, four-wheel drive, automatic transmission, short bed, and the Z71 trim package. The Chevrolet model designation for this vehicle is K10753. At the time of the accident the Chevrolet was equipped with a 6 inch lift kit manufactured by Rough Country. In addition, the Chevrolet had a set of oversized tires and a set of rear lowering shackles that were not manufactured by Rough Country. Kineticcorp determined that this specific K1500, including the Rough Country lift kit, Dick Cepek tires, the driver and cargo, weighed approximately 5,185 lbs. at the time of the crash. Figure 12 contains photographs of the K1500 taken by Kineticcorp during an inspection of the vehicle. As seen in figure 12, the subject K1500 has extensive frontal impact damage from the collision with the Toyota Sienna. This damage is heavily biased toward the driver's side of the vehicle. As seen in the photographs, the left front wheel of the Chevrolet was engaged during the crash and broken.

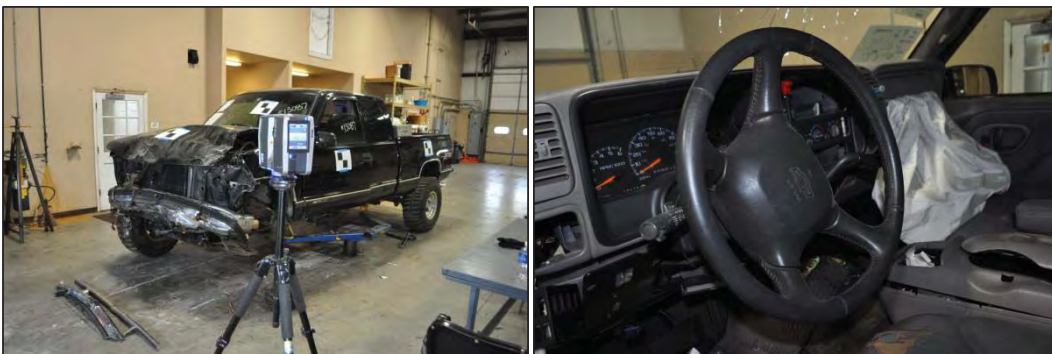
*Figure 13 - Subject 1999 Chevrolet Pickup*

The photographs in Figure 13 contain two additional inspection photos taken by Kineticcorp. The vehicle was inspected, photographed, documented and scanned using a Faro Focus 3D scanner. The left image shows the Faro scanning the subject Chevrolet. As seen in the right image, the passenger airbag deployed and the driver's airbag was not deployed during this crash. Event data from the Airbag Control Module was recovered by Sgt. Keith Addis on December, 27 2012 using the Crash Data Retrieval (CDR) system. A copy of this data report was provided to Kineticcorp and utilized in the reconstruction of the incident. The CDR report discussed later in this report indicates that the Supplemental Inflatable Restraint (SIR) warning lamp was illuminated at the time of the crash.

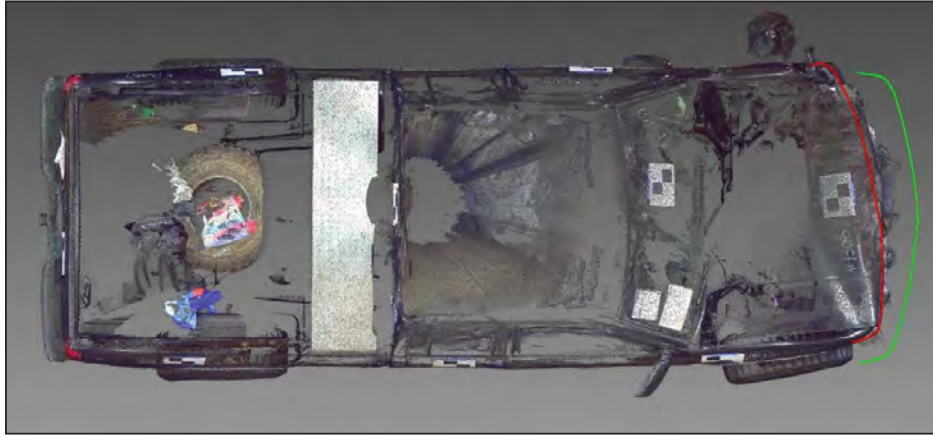
*Figure 17 – Chevrolet K1500 Damage*

Kineticorp used the scan data from the subject and exemplar Chevrolet vehicles to determine the extent of damage sustained by the subject Chevrolet. Figure 17 is a top view of the subject vehicle model annotated with two colored lines representing the relative bumper locations and the extent of damage caused by the accident. The green line indicates the location of the undamaged bumper and the red line indicates the location of the subject vehicle bumper.

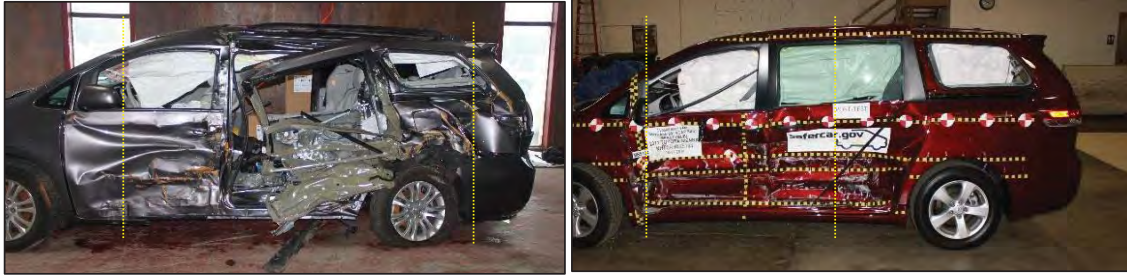
*Figure 22 – Damage Comparison: Subject Vehicle (Left) vs. NCAP Test Vehicle (Right)*

Kineticorp compared the vehicle damage experienced in the subject accident to the National Highway Traffic Safety Administration (NHTSA) New Car Assessment Program (NCAP) side impact test (number 6944). Figure 22 below shows a pair of images comparing damage of the subject vehicle on the left to the damage of the NCAP test vehicle on the right. As seen in the photos, indicated by the vertical dotted yellow lines, the NCAP test vehicle had significantly less damage width than the accident vehicle. The damage width for the NCAP test was about 94 inches while the damage width on the accident vehicle was about 116 inches. The maximum crush depth measured in the NCAP test was 9.8 inches while the accident vehicle showed at least 12 inches of crush.

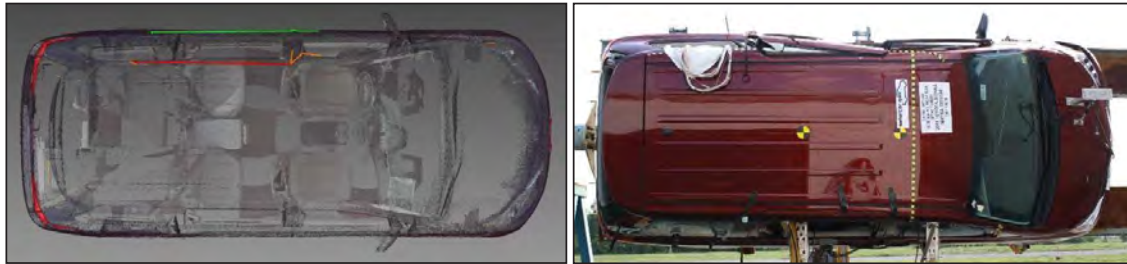
*Figure 23 – Damage Comparison: Subject Vehicle (Left) vs. NCAP Test Vehicle (Right)*

Figure 23 contains a graphic depicting damage to the subject vehicle on the left compared to a top view photograph of the test vehicle on the right. As seen in Figure 23, the damage to the side of the subject vehicle extends inboard much further than the damage seen on the test vehicle.

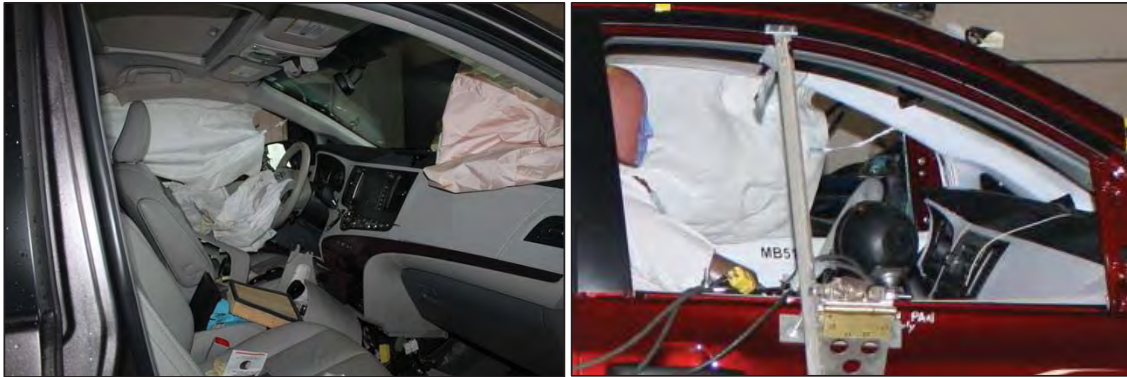
*Figure 24 – Interior Comparison: Subject Vehicle (Left) vs. NCAP Test Vehicle (Right)*

The impact angles and relative speeds of the vehicles were significantly different between the subject accident and the NCAP test. The accident impact began with contact to the driver's door and b-pillar that caused the left front corner of the Chevrolet to be deformed rearward. The relative motion of the vehicles caused both to rotate counterclockwise. As the contact continued the front of the Chevrolet rolled across the side of the Toyota toward the area of the C-pillar. This contact and rotation caused a significant rearward speed change for the Toyota which likely led to a deployment of the frontal airbags. Figure 24 contains interior views of the subject and NCAP test vehicles. As seen in the photos the NCAP test did not cause a frontal airbag deployment.
